Precast Big Block Furnace Refractory Lining for Rebuild

Primary Aluminium Plant, Holding Furnace
Metal Temperature: 720°C (1328°F)

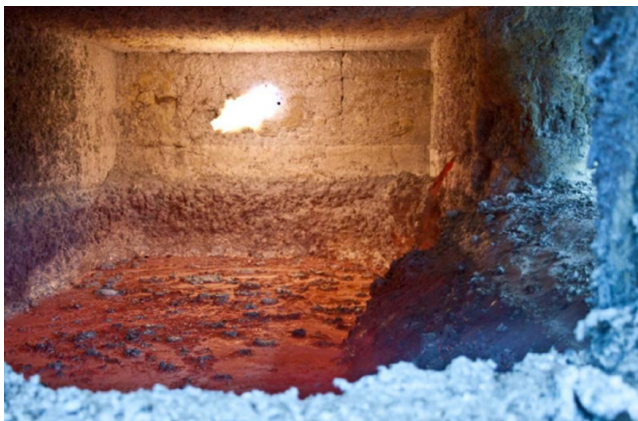
The furnace—last re-lined 15 years prior—displayed significant refractory deterioration with excessive corundum buildup around the top of the metal level and loosening lamination repairs in danger of falling off into the melt. The steel shell of the furnace showed signs of excessive heat wear caused by the worn insulating refractory.

Furnace appearance before rebuild

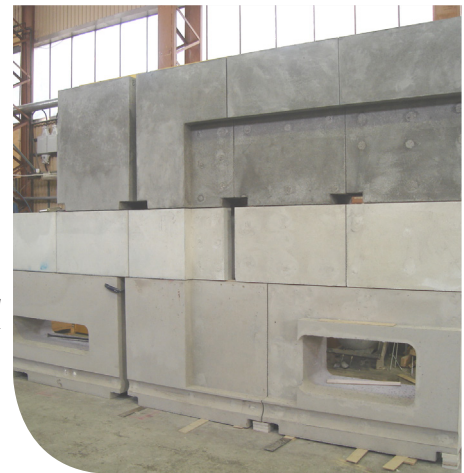
Rebuild was performed using Pyrotek precast furnace shapes

on usage and process needs, a material package was provided per area of the furnace: lower wall, upper wall, roof, lintels, jambs, sill, and hearth.
